Location 3: Glenmore Tr SW: Phase 2
Sound Wall Lifecycle Replacement Program

Date: May 2023

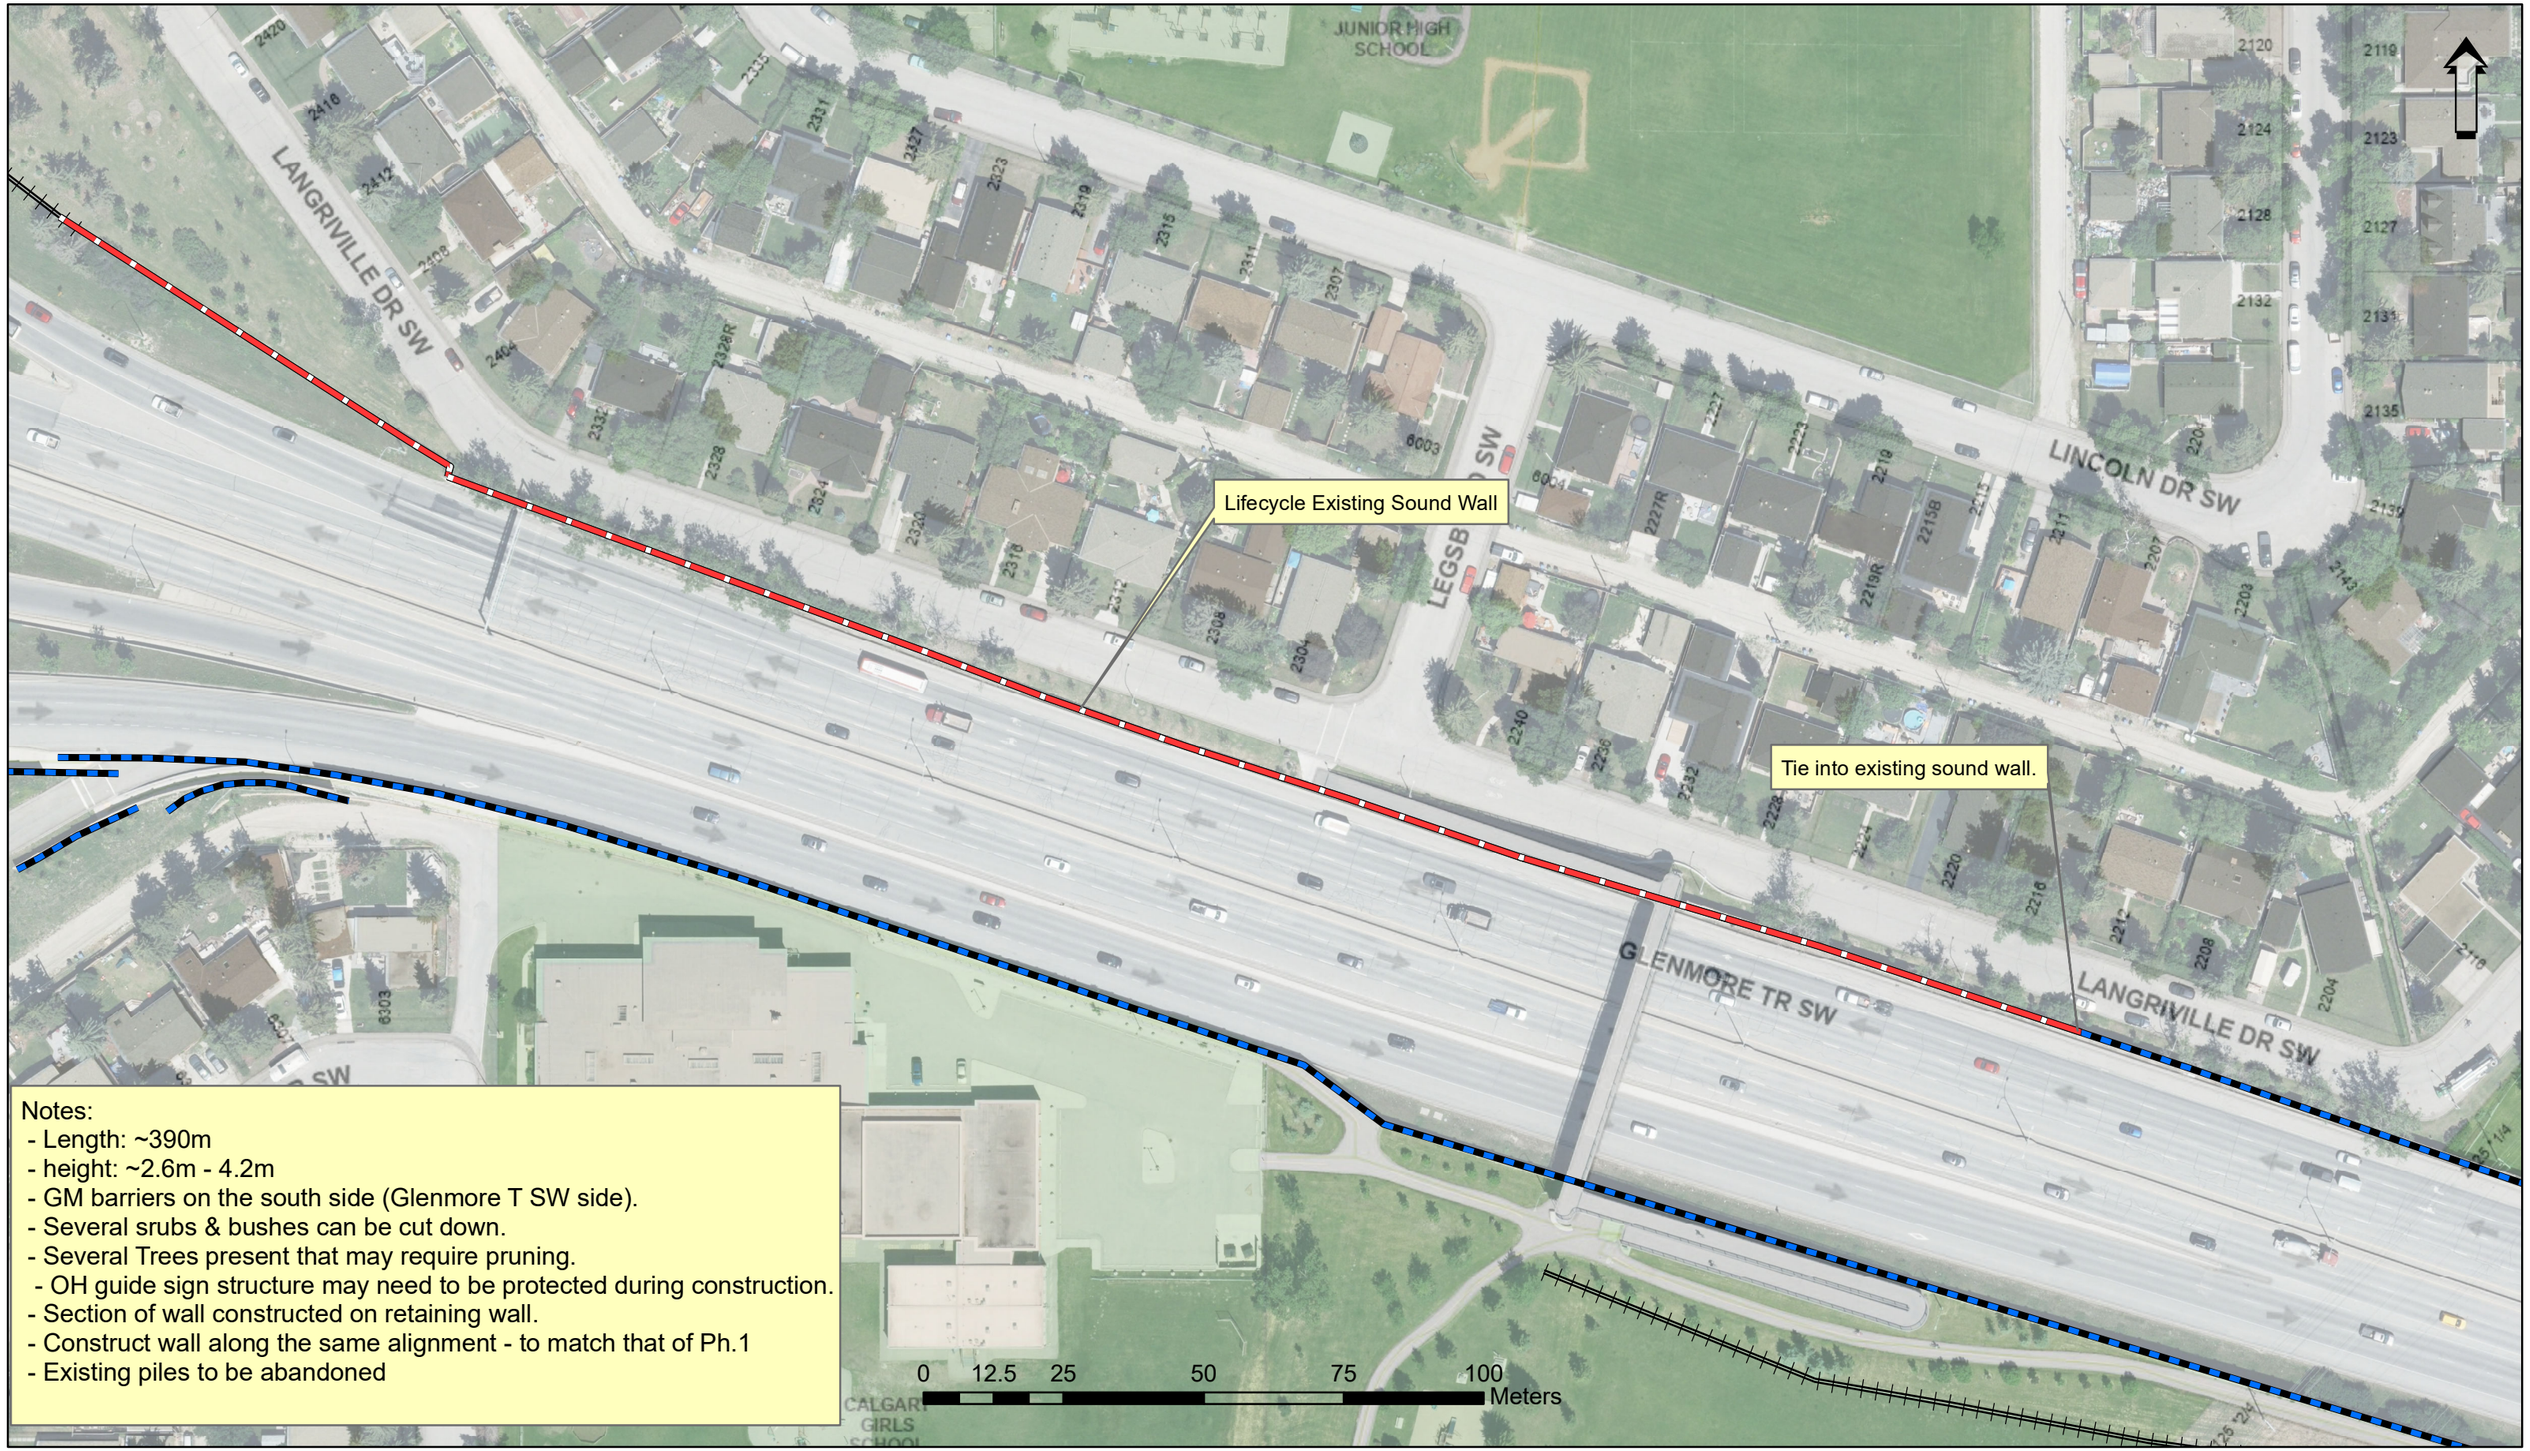
Notes:
- Length: ~390m
- height: ~2.6m - 4.2m
- GM barriers on the south side (Glenmore T SW side).
- Several srubs & bushes can be cut down.
- Several Trees present that may require pruning.
- OH guide sign structure may need to be protected during construction.
- Section of wall constructed on retaining wall.
- Construct wall along the same alignment - to match that of Ph.1
- Existing piles to be abandoned
